MORE COMPREHENSION, MORE PROTECTION: NON-DESTRUCTIVE TECHNIQUES IN THE SURVEY OF THE FORMER S. SALVATORE HOSPITAL IN L'AQUILA, ITALY

*Mariangela De Vita**, *Giulia Massari***, *Pierluigi De Berardinis***, *Luis Palmero Iglesias****

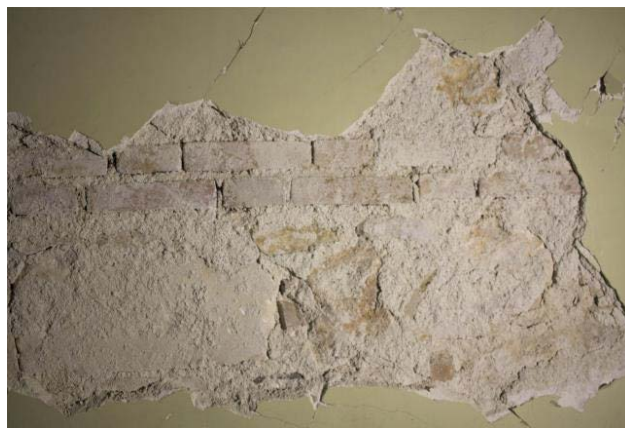
Fig. 3: The *muratura listata* visible thanks to the detachment of the plaster

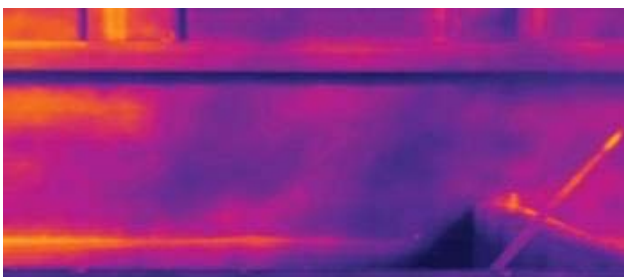
The objective of this specific test was the thermohygro-metric verification of the masonry, which results in determining the presence of water inside the wall caused by water infiltration, or the lack of it, as shown in figure 8.

Fig. 8: Presence of water detected on the South façade

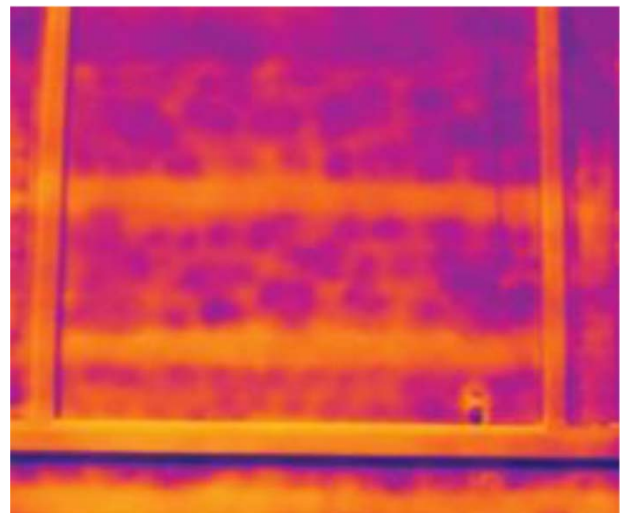
Fig. 9: Wall texture - masonry striped with stones with double recourse of brick

With the thermographic tests, through the prospectus reconstruction, it was possible both to find anomalies in the building and to verify the data of which there was not absolute certainty. One of the problems detected was the capillary ascent, highlighted in the façades analysed through passive mode. The examination of the masonry texture was interesting, which was instead highlighted in the façades analysed in active mode. The historical sources of the building had provided information on the type of wall texture, composed by striped masonry of stones

with double bricks recourse every 0.60 m and information on the presence of reinforced concrete pillars in some areas of the building. By means of the thermographic analysis, it was possible to verify both the exact position of the double recourse of bricks and the actual presence position of the pillars. It was also possible to detect the presence of ring beam of which we did not have certain information before the surveys carried out.

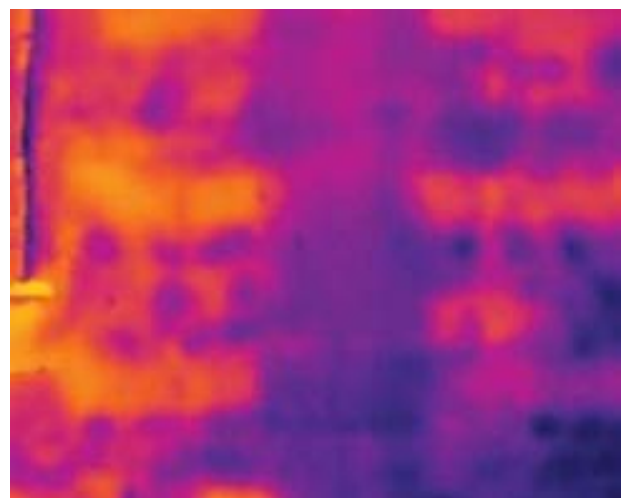
Fig. 10: Wall texture - mixed structure consisting of masonry walls and reinforced concrete pillar

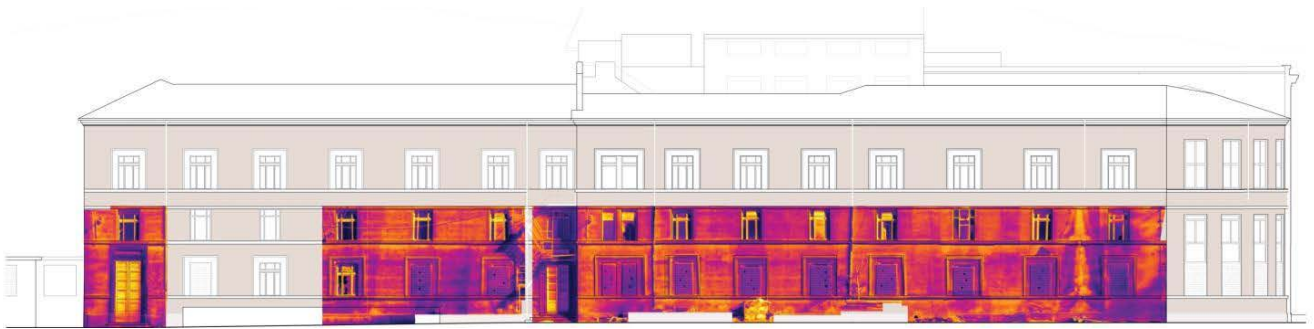
Fig. 11: South façade - time: 10:00

In the figure 11 it is possible to see the reconstruction of the south façade analysed in passive mode and in the figure 12 the reconstruction of the south façade analysed in active mode. The reconstruction of the north and west façades is shown in the figures 13 and 14.

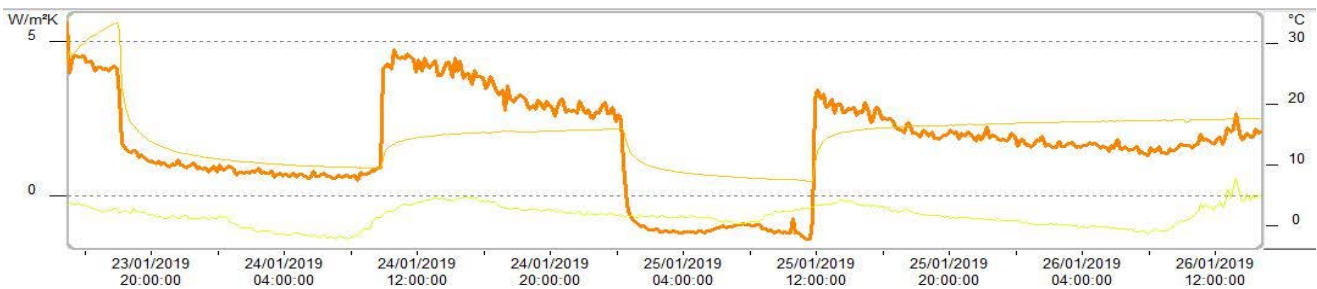
The values were analysed using the Testo Comfort Software Professional 4, which can store and read the collected data and draw graphs with it. In figure 18 it is possible to see the graph of the monitoring data: in the first hours of it, the values were very fluctuating while in the last 24 hours they stabilized, providing the correct U-value (W/m²K).

Considering the last 24 monitoring hours, during which the internal conditions of the room have been stabilized (constant temperature), the U-value has been measured making an arithmetic average of all the valid values obtained (table 2).

Fig. 18: Graph of the monitoring results
