SCIENTIFIC AND INTERDISCIPLINARY METHOD AS SUPPORT FOR THE RESTORATION PROJECT. THE BALUSTRADE STEPS OF VILLA CERAMI.

Giulia Sanfilippo*, Erica Aquilia**, Graziana D'Agostino*

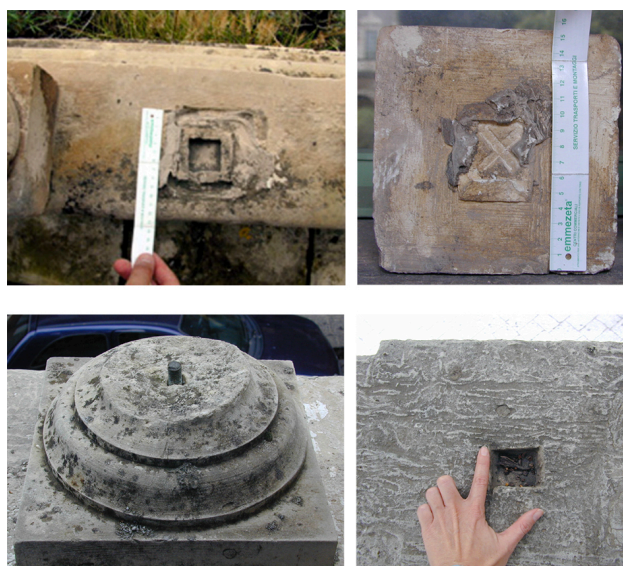
Fig. 5: Above: Benedictine monastery, link between plinth and the base of the baluster. Below: Villa Cerami; base of a yard with metal pin; link between plinth and the base of the baluster

The embedding made to host the fuses has a squared shape (in the monastery they have the size of 9cm per side, and in the villa 7cm per side). We could not find any piece displaying small holes indicative of the insertion of metal joints to ensure the base of the baluster, except for the jars on the small pilasters of villa Cerami (Fig. 5).

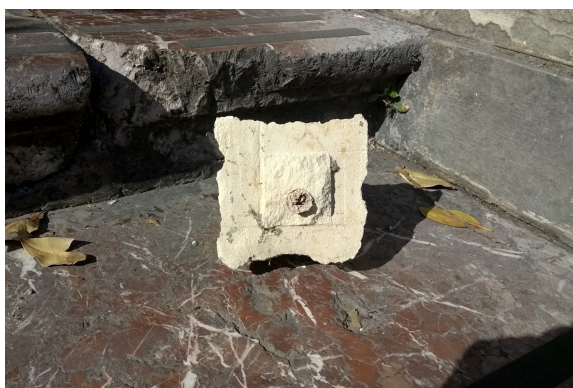
But in adjacent to the exedra, we observed, from the abacus of the collapsed baluster, that the frame with the handrail stone is secured by a wood pin (Fig. 6).

The technique of sewing stone blocks between them was common ever since ancient times although the joining material was usually consisting of lead or stone tiles. Clearly the wood is a material subject to sudden degradation, especially if in contact with moisture.

Fig. 6: Abacus of the collapsed baluster, showing wood pin

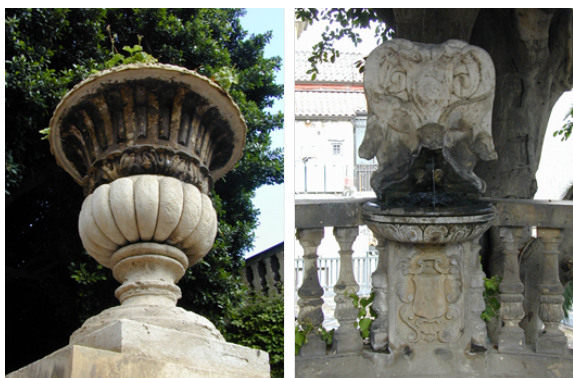
Fig. 7: Stone yard and fountain stone with black crust and biological layers

In agreement with what was said, the more frequent pathologies recognised in this study were: black crust, i.e. the external surface made of both biological layers and dangerous polluting substances; erosion, along with material detachment and loss, are instead concentrated on a few elements of the stair, such as the small pilaster on the left side of the first flight, on the small columns of the balusters and on the exedra at the level of the first half space. The extent and importance of the decay is linked to the features of the material, exposure and shape of the balusters. In fact, the deposit of polluting substances accumulates in the areas that are not reached by atmospheric agents, i.e. below the overhang and inside the bas-survey. For a Baroque balustrade, then, the more risky zones are the top of the small columns protected by the upper overhang of the stone handrail stone, and specifically, the inner parts of the elaborated engravings of the central fountain, the front sides of the small pilasters and their decoration jars.

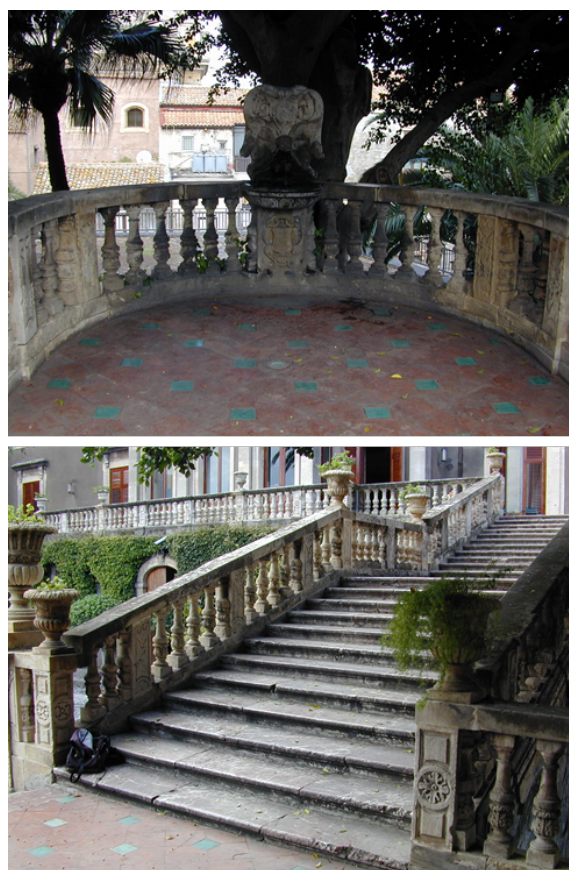
In particular, in the portion of balustrade on the first landing, exedra shaped and located under a big ficus, the part of the exedra facing west

appears more degraded. This degradation is favoured to a bad exposure, to the presence of the tree which gives shade and does not allow for the fast evaporation of water and promotes the proliferation of microorganisms; and finally to the presence of the adjacent fountain which over time probably caused phenomena of run-off and then rising dampness in the pillars.

Fig 8: View of the exedra of and the staircase

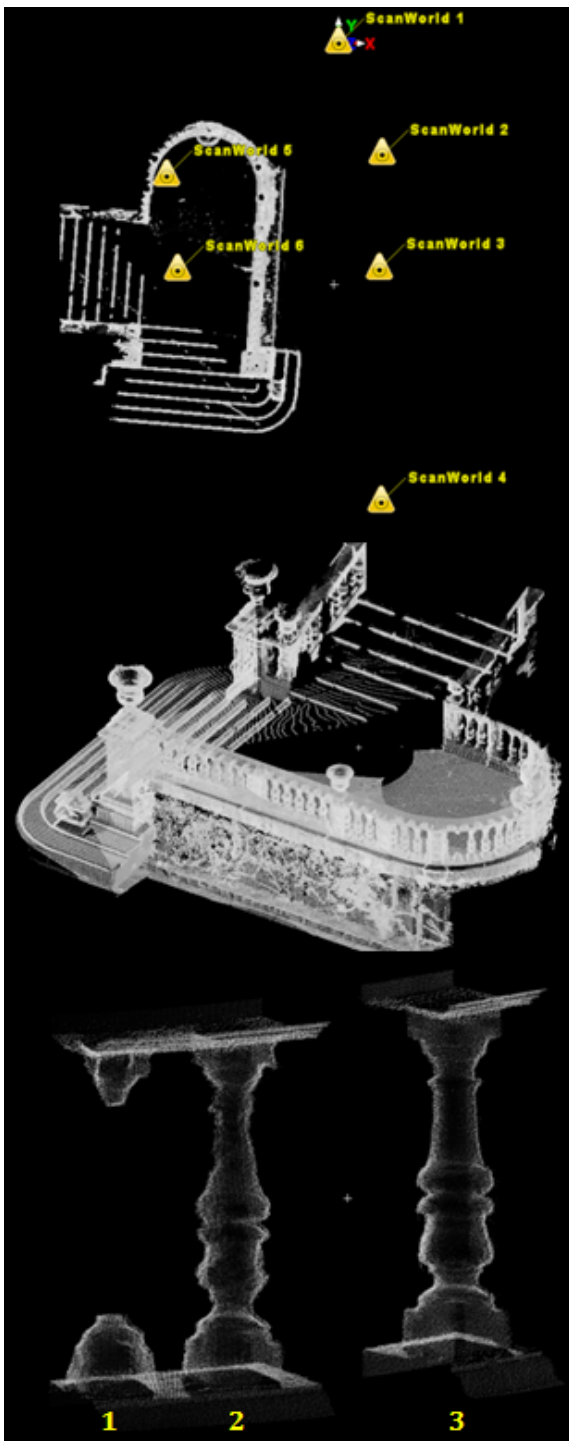
Fig. 9: Above, the survey project and point stations of survey through 3D Laser Scanner (6 shooting stations); at the center, the point cloud (13, 694, 137 points); below, balustrades studied

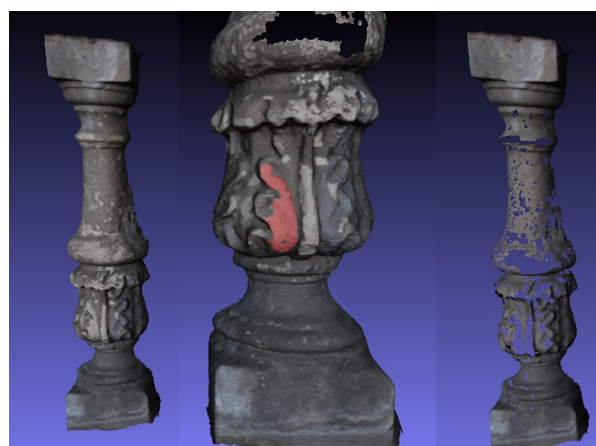
The area of baluster 3 affected by the black crust was calculated using 3D photo modelling. Since the model contains the real colour textures, the healthy parts of the baluster have been lifted through physical elimination of mesh parts, within the software MashLab and the subsequent remaining area calculation (Fig. 12).

Fig. 12: On the left, polygonal model of baluster 3 reconstructed through 123D Catch; at the center, in red part of mesh selection not subject to degradation; right, final processing of polygonal model of the entire area covered by the black crust

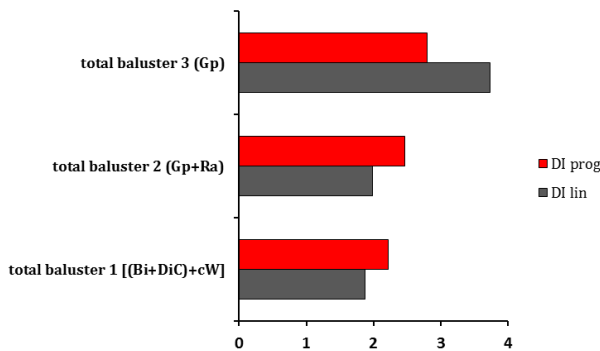
The bar diagram in Fig. 14 shows a total damage indices very high to the third baluster, a

high damage to the second baluster and finally a moderate damage to the first baluster.

Fig.14 Calculated damage's indices for each studied balusters. Prog= progressive; lin= linear; total baluster #= total indices to the each baluster

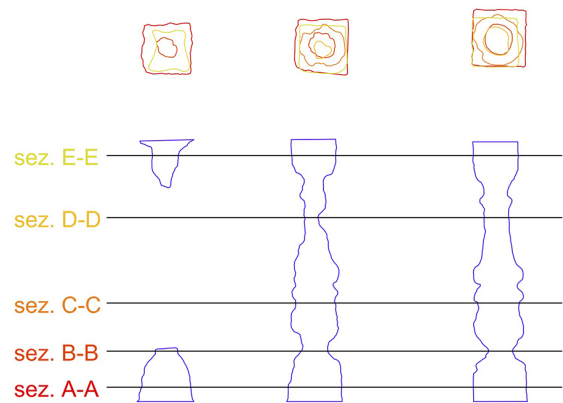
Fig.15 Scheme of sections and planes of balusters 1-2-3

-Finally, in the third case, it could be sufficient to carry out a cleaning intervention to remove the black crust and deposits of biological nature; in this way, the baluster could continue to perform its aesthetic and structural function.

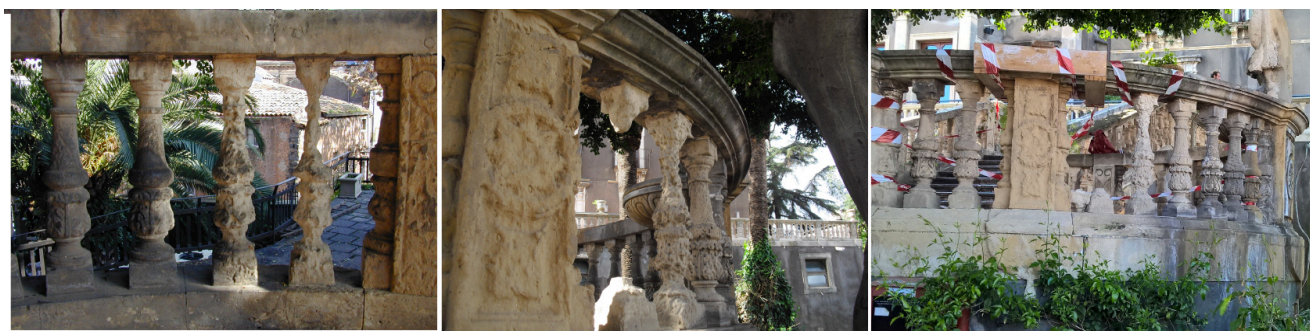
Fig.16: Three stages of decay: on the left photo of 2001; in the centre, the baluster without spindle (February 2015) and on the right, collapse of the capital and of the handrail overlying (May 2015)

The cleaning operation should be aimed at “liberating” the image from black crusts and biodeteriogens; also because these degradations damage the stone material.

At the end, the third way could be pure conservation, leaving the natural state of the element of deformation. The balustrade’s image, in its entirety, would not be compromised but in time, the disintegration would gradually increase until its collapse (as happened to the baluster on the right) of the element. The project aims to stop this degenerative process. Besides, the evaluation of cultural reasons has to look for answers based on scientific and technical analyses in order to identify the most efficient protective substance.
