A PROPOSAL FOR A NEW STANDARD QUANTIFICATION OF DAMAGES OF CULTURAL HERITAGES, BASED ON 3D SCANNING

Rosella Alessia Galantucci, Fabio Fatiguso*, Luigi Maria Galantucci***

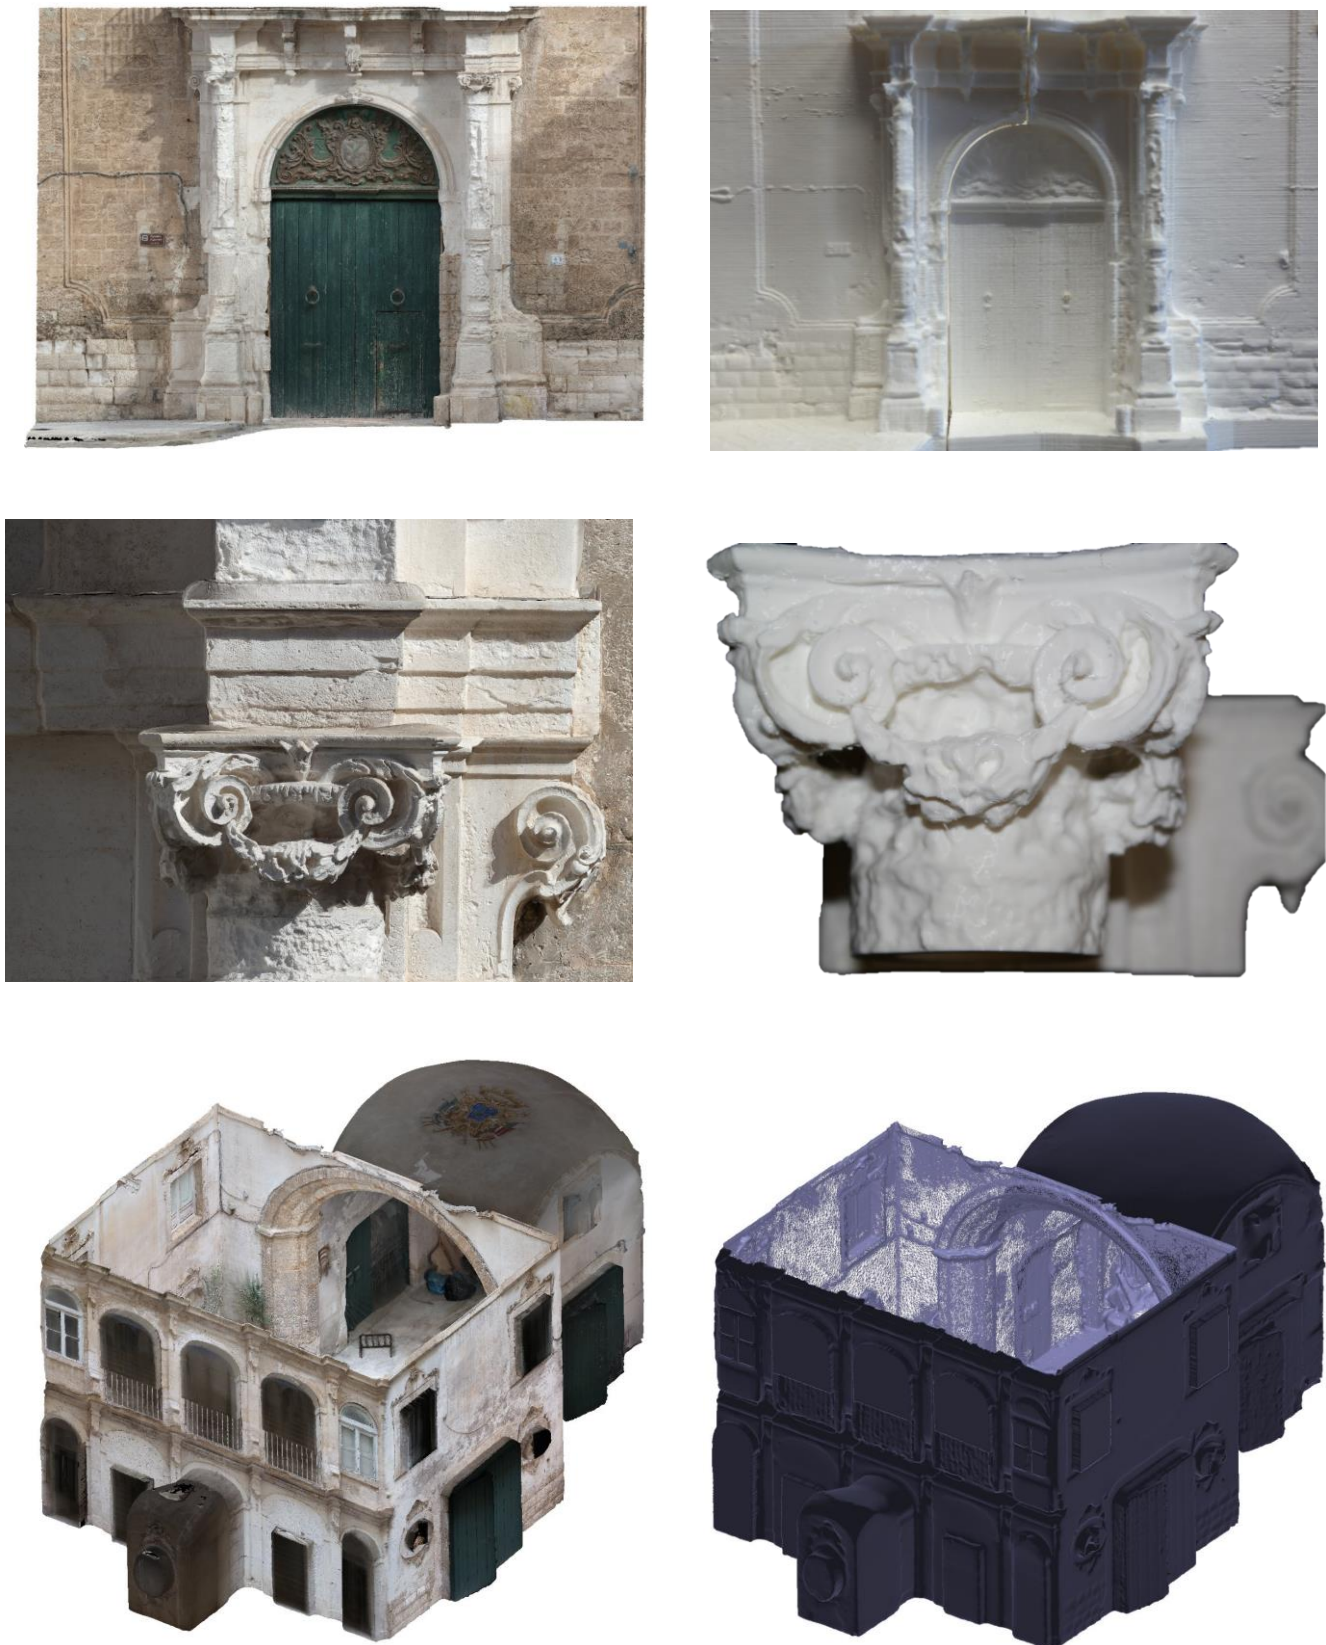
Fig. 2: Polygonal meshes (with textures) of the portal, the right ionic capital, and the internal atrium and courtyard; 3D printed models of the same elements

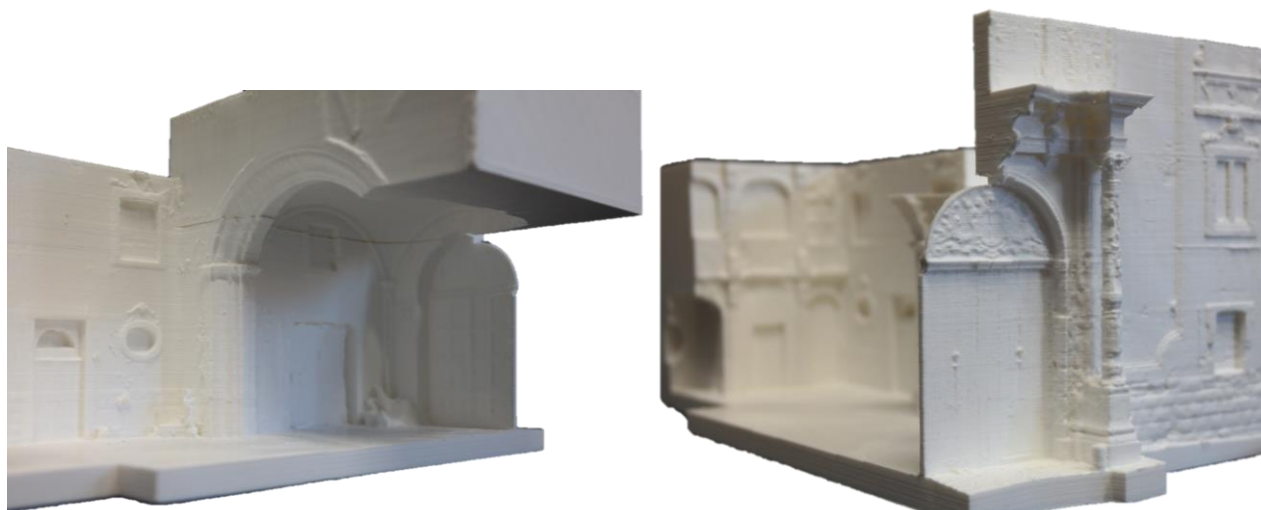
Fig. 3: 3D printed model of the internal courtyard

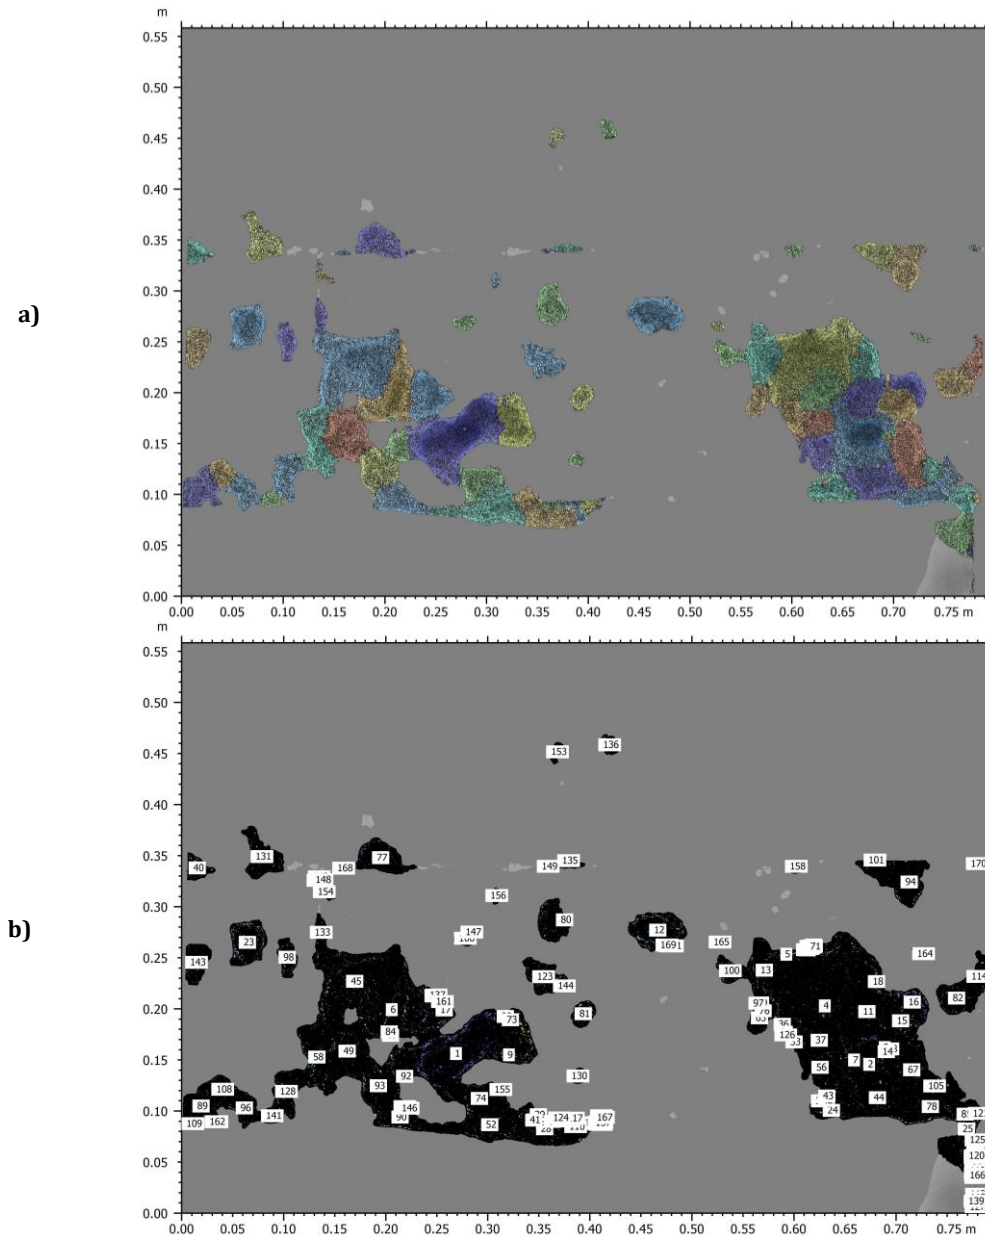
Fig. 6: a) Analysis of the motifs identified by the software, after the definition of two thresholds in depth and area; b) Motifs with labels associated to their number; Table with the calculation of all the parameters

The *studiables*⁵ were further elaborated through the motifs' analysis (Fig. 6), obtaining, for each detected motif, quantitative measures like area, volume, depth, coplanarity, minimum, maximum diameter, orientation, aspect ratio, roundness, compactness.

In fact, studies like binarization (fig. 5), for 2D parameters and motifs' analysis (fig. 6), for 3D parameters, give information about depth, area, volume, shape, orientation of each motif. In table 2 (DigitalSurf, 2016) there are all the parameters taken into consideration in this research. They concern important geometrical characteristics, which could help understanding, identifying and classifying a pathology. In fact, for example the depth (height) of a grain is useful to understand if a defect is superficial or deep. Area, maximum and minimum diameter are useful to know precisely the flat dimensions of the defect. Parameters like aspect ratio, roundness and compactness allow to classify the motifs according to their form.
