CULTURAL HERITAGE RECOVERY IN RURAL SPAIN THROUGH DIGITAL MEANS OF SURVEYING AND GRAPHIC RECONSTRUCTION. CASE STUDY OF EL PAULAR WOOL COMPLEX.

*Department of Architecture, University of Alcalá – Madrid, Spain.

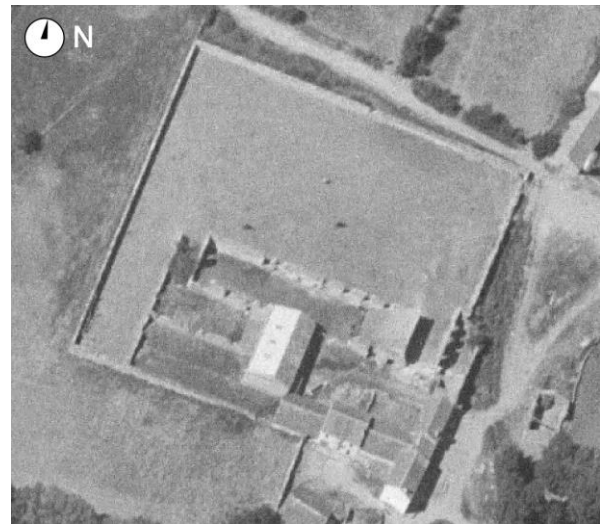
Fig. 2: Aerial photography. National Geographic Institute (Spain), Interministerial flight, photo.0483B0009, 1973.

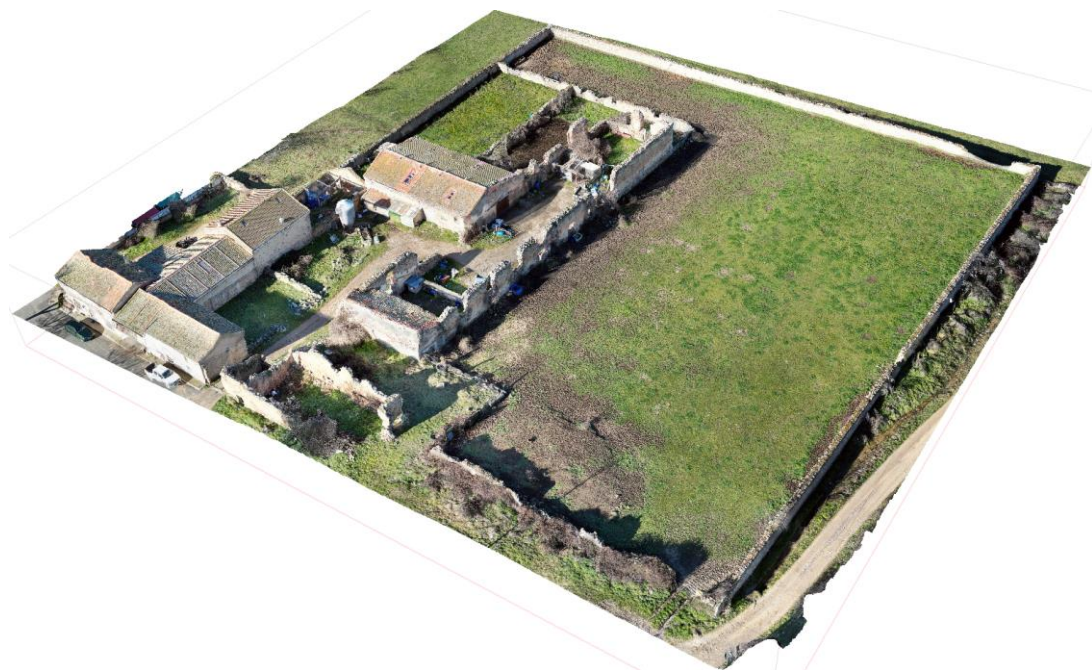
Fig. 1: Full photogrammetric survey model of cultural heritage. Aerial perspective. By the author.

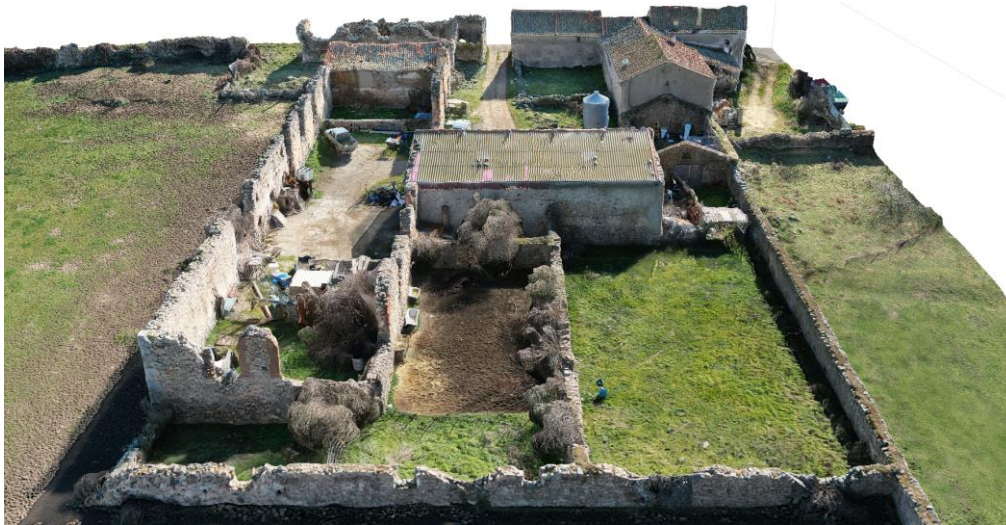
Fig. 3: Concentration of ruins inside the complex. Partial aerial view of the photogrammetric survey model. By the author.

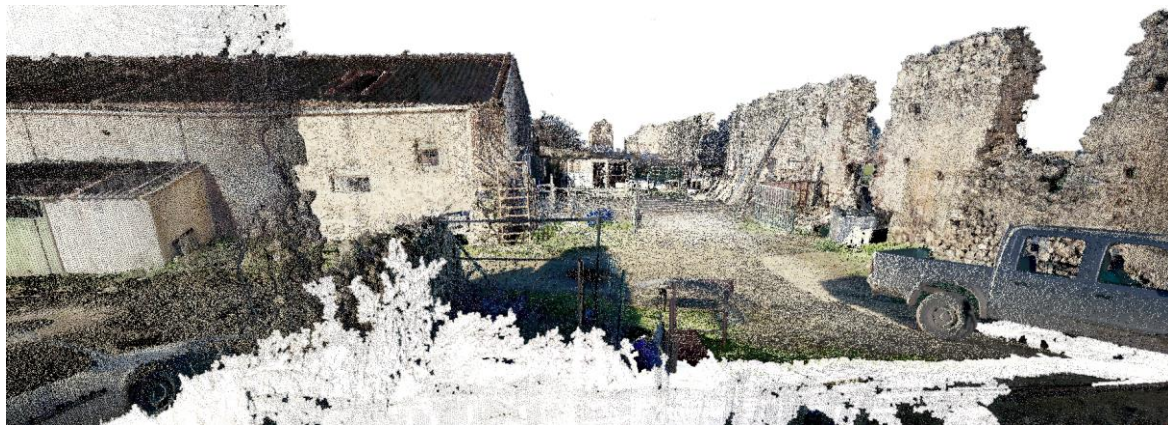
Fig. 4: Inside view of point cloud model of cultural heritage. By the author.

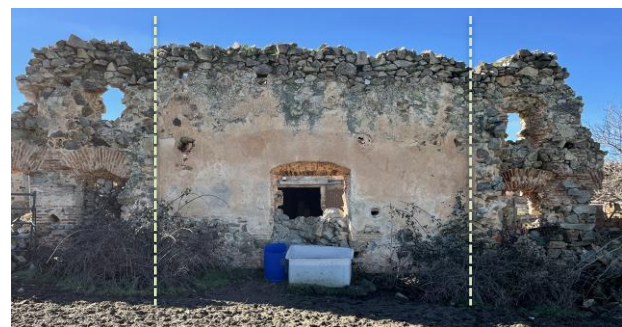
Fig. 5. Difference of historical plastering show old interior spaces. By the author.

existence of different spaces (essentially open but also closed), the significant height of the walls that make up the ruin, the impossibility of accessing all the spaces and objects and, finally, the need to collect graphically the elements that are difficult to access, as a means of correctly interpreting the vestiges that constitute this cultural heritage. It is also particularly important for the research to make a correct reading of the walls and specifically of the existing historical plastering, which make it possible to determine the primitive location of the preserved remains (interior or exterior) as well as the existence of possible buildings that today are missing (Fig. 5).

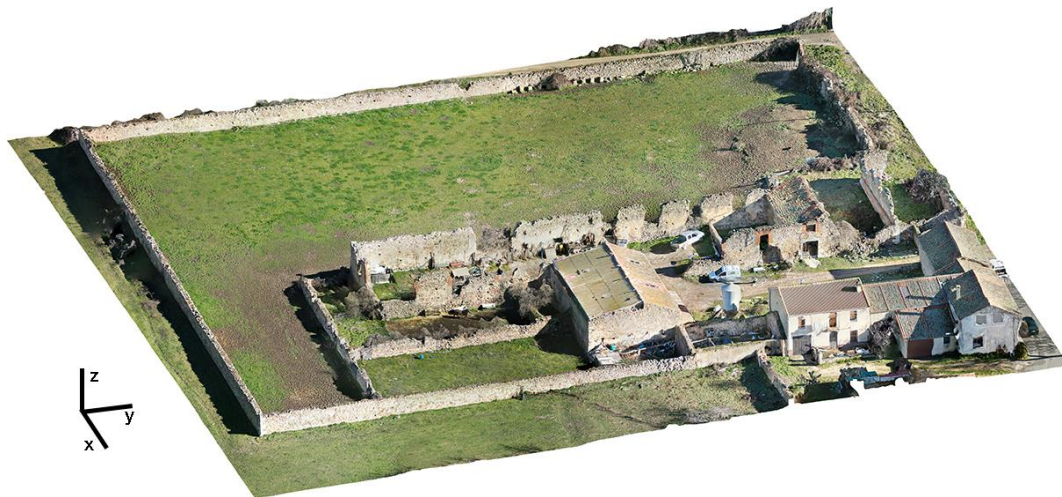
Fig. 6: Axonometric view of the photogrammetric survey model. By the author.

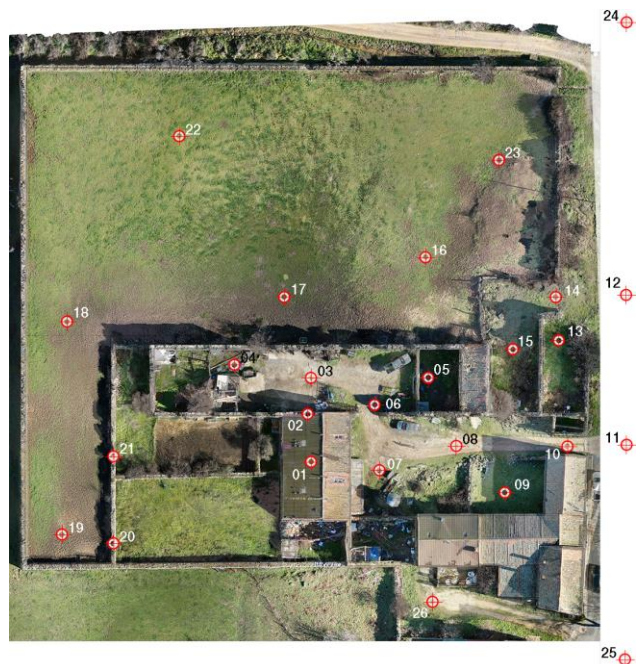
Fig. 7: Location of scanning stations. Combined plan of scanner and photogrammetry models. By the author.

The programming of the work campaigns was complex due to the unfavorable winter weather in the surrounding mountains, making it necessary to delay the campaigns on two occasions due to strong wind and rain. After requesting the municipal permits and carrying out a first prior reconnaissance visit, the digital survey campaign was carried out in a full day (approx. 3.5h to scan and 1.2h to fly). It was chosen to carry out the campaign in winter to avoid the proliferation of vegetation that could obstruct the view of the ruins, obtaining very good results in this regard. However, operating in rural areas forced us to have numerous batteries due to the impossibility of finding means to recharge, as was observed in the first reconnaissance visit, using 4 complete batteries for the drone and 3 for the scanner. For this reason, and according to the times of each instrument, before the survey different plans were

drawn up indicating the location and specific number of stations, the number of aerial photographs necessary, as well as the location of each one of them, allowing the development of an effective field work.

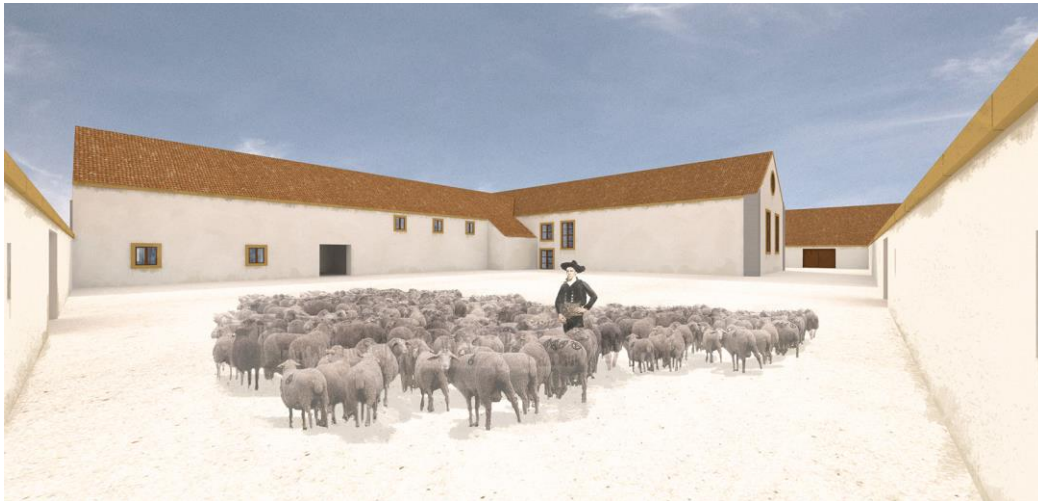
Fig. 14: Reconstruction of the northwest patio, where the sheared cattle were located. Narrative representation. By the author.

pen in order to prevent them from being exposed to the elements and, if the weather was fine, they were taken out to the adjacent courtyards to get used to their new unsheltered state (Figs. 14 and 15).

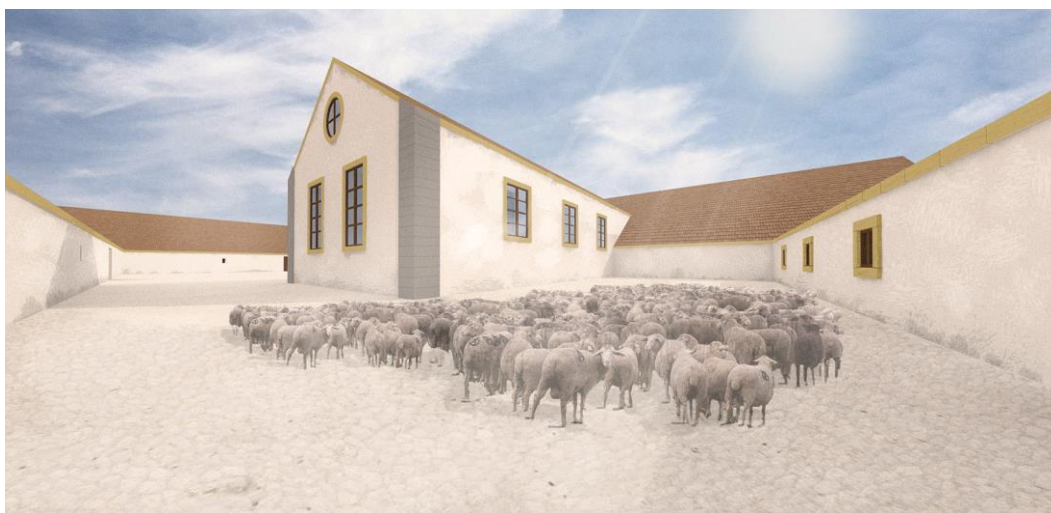
Fig. 15: Reconstruction of the southwest courtyard, highlighting the shearing room gable. Narrative representation. By the author.

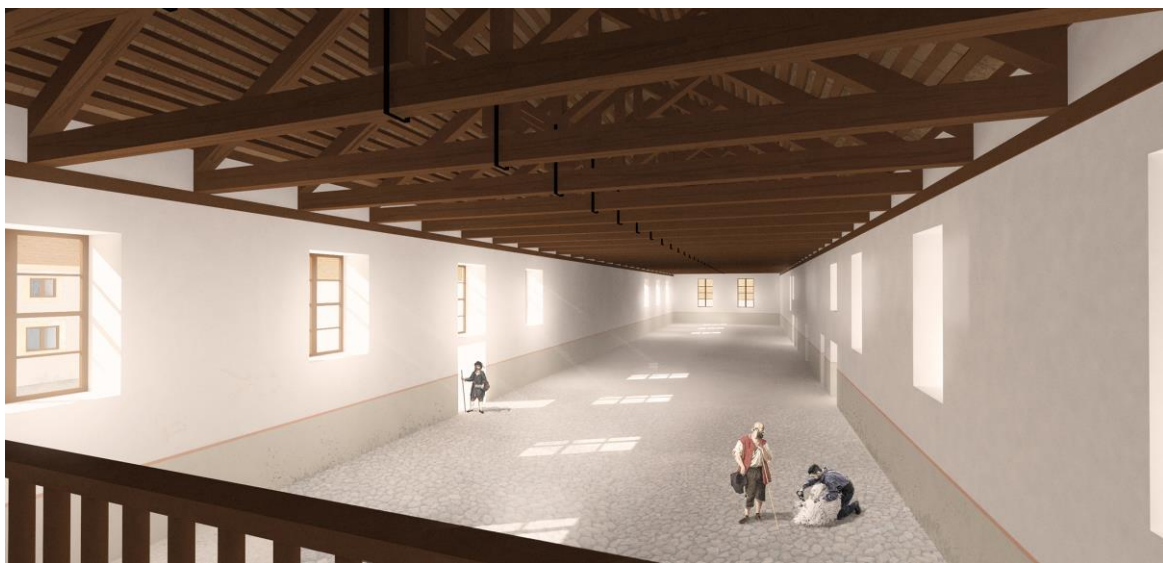
Fig. 18: Reconstruction of the shearing room from the cantilever gallery located after the oratory, through which the monks observed the execution of the operations. Narrative representation. By the author.

sections was the private oratory, as recorded in the historical documents and in the ruin itself. In addition, we have discovered that after the oratory the monks had a privileged space in the shearing room through a cantilevered gallery from which they controlled all operations (Fig. 18).

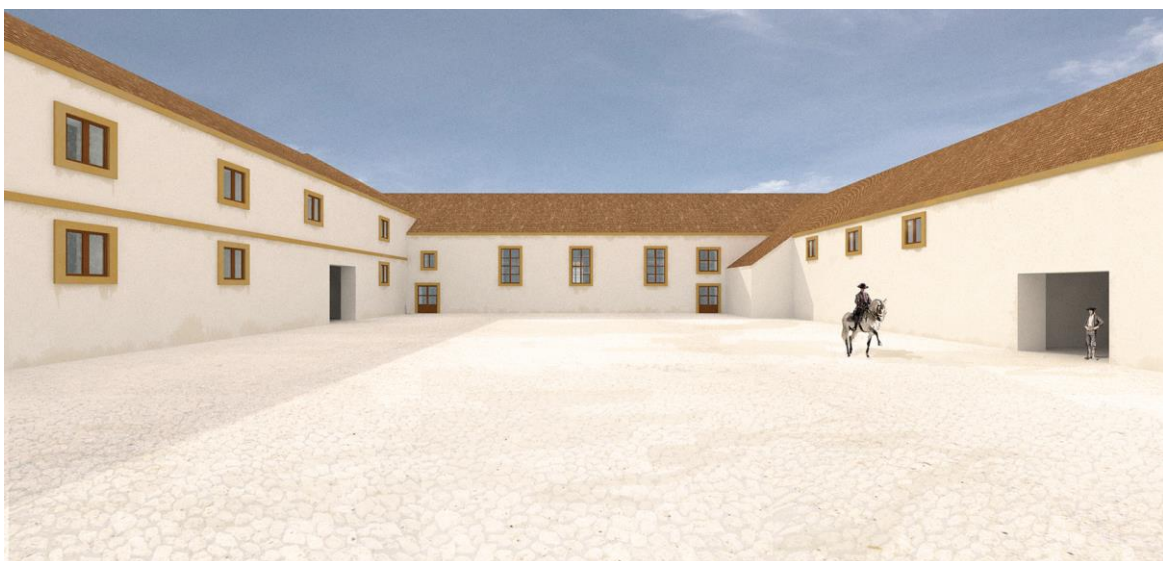
Fig. 19: Reconstruction of the main northeast patio, around which the Carthusian house was located (left), as well as the shearing room (in the background) and the passage to the next courtyard (right). Narrative representation. By the author.

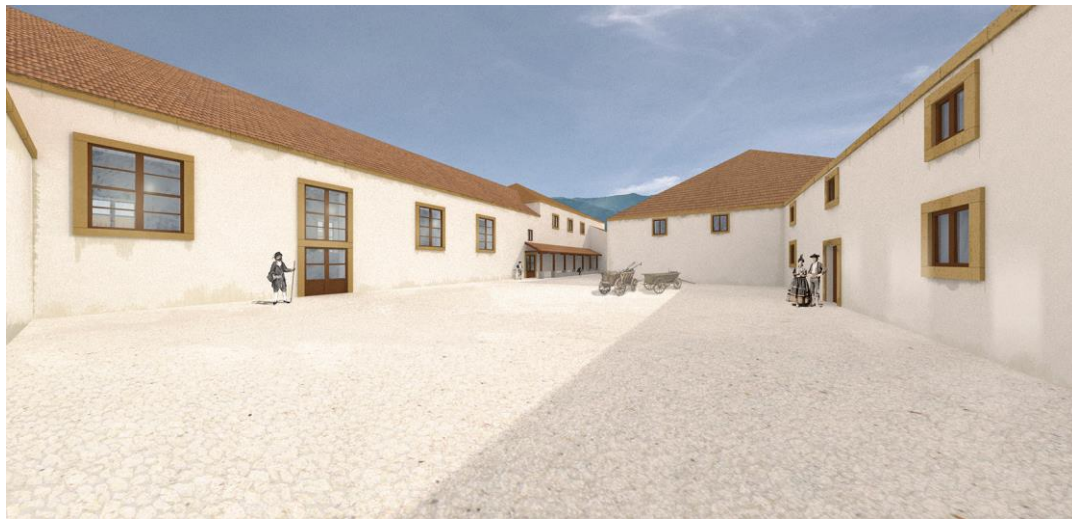
Fig. 20: Reconstruction of the southeast patio around which the spaces for provisioning the workers were located, as well as the access to the shearing room (on the left). Narrative representation. By the author.
