MORE COMPREHENSION, MORE PROTECTION: NON-DESTRUCTIVE TECHNIQUES IN THE SURVEY OF THE FORMER S. SALVATORE HOSPITAL IN L'AQUILA, ITALY

*Mariangela De Vita**, *Giulia Massari***, *Pierluigi De Berardinis***, *Luis Palmero Iglesias****

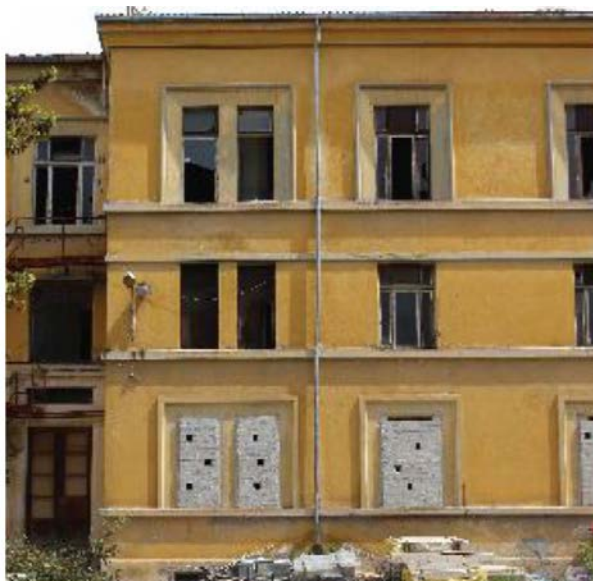
Fig. 5: Part of the south façade analysed

The work presented in this paper belongs to the aforementioned context and, in particular way, aims to investigate the distinctive part of the architectural complex corresponding to the 1931 extension and characterized by a singular *muratura listata* (figure 3) in which there are reinforced concrete pillars, probably conferring a greater rigidity to the structure which presents some fragility mainly due to its irregular shape and a big internal court, as it can be seen in figures 4, 5.

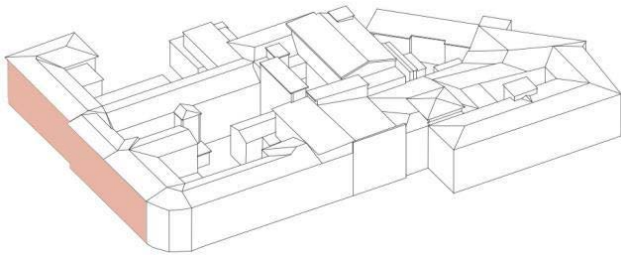
Fig. 6: South façade highlighted in red

Taking the elevation with the highlighted south façade as an example (figures 6 and 7), it is possible to understand the used methodology. The façade was analysed at 10:00 a.m. in passive mode, detecting the energy emitted under stationary operating conditions, which is when the element is in thermal equilibrium.

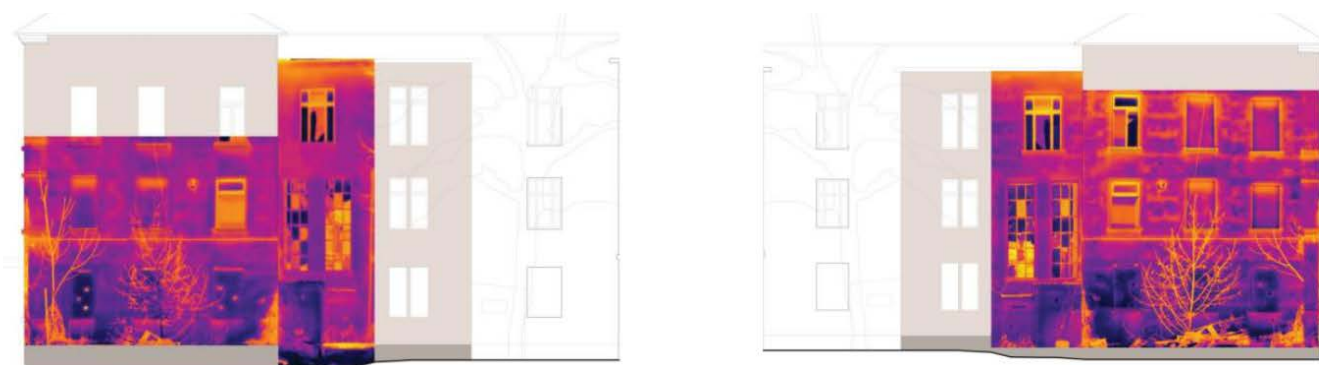
Fig. 13: North façade -time: 11:00 and 15:00

In the figure 11 it is possible to see the reconstruction of the south façade analysed in passive mode and in the figure 12 the reconstruction of the south façade analysed in active mode. The reconstruction of the north and west façades is shown in the figures 13 and 14.

With the thermographic tests, through the prospectus reconstruction, it was possible both to find anomalies in the building and to verify the data of which there was not absolute certainty. One of the problems detected was the capillary ascent, highlighted in the façades analysed through passive mode. The examination of the masonry texture was interesting, which was instead highlighted in the façades analysed in active mode. The historical sources of the building had provided information on the type of wall texture, composed by striped masonry of stones
